ARCCA, INCORPORATED
2288 SECOND STREET PIKE
P.O. BOX 78
PENNS PARK, PA 18943
PHONE 215-598-9750 FAX 215-598-9751
www.arcca.com

Re: Iijima, Mayumi administrator for Estate of Ryo Oyamada v. New York City
U.S. District Court, Eastern District of New York
Index #: 13CV2688 (ARR)
DOL: 2/21/2013
ARCCA File No.: 4828-004

BACKGROUND

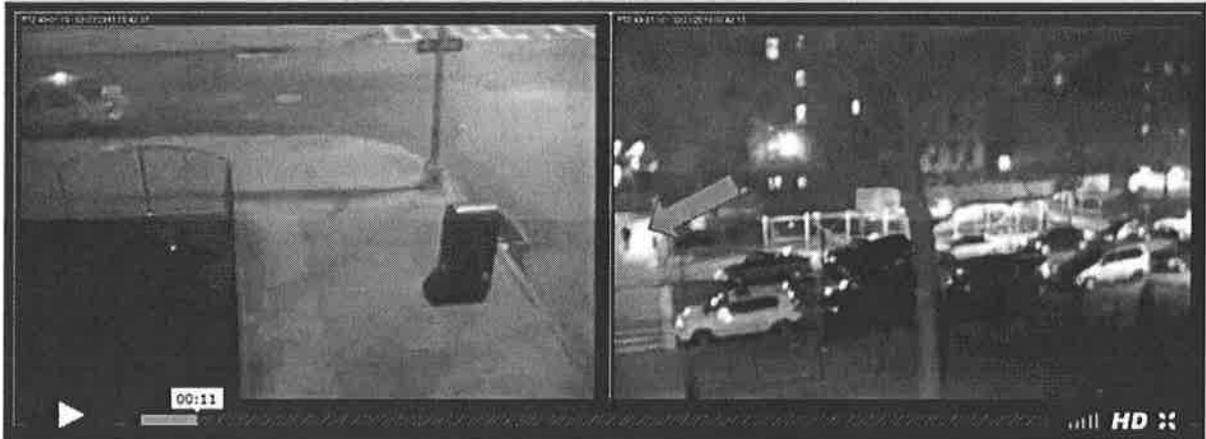
- Videos were available via a link to the Gothamist, dated August 20, 2014.
- The video links to Vimeo which contained two video camera views contained within the same video: Camera 1 and Camera 2.
- Camera 1 (left in view) was mounted at the southeast corner of 40th Avenue and 10th Street, while Camera 2 (right in view) was mounted on the southwest corner of 40th Avenue and 12th Street.
- At the start of the video, Camera 1 had a date and time stamp of 02/21/2013 00:42:01, while Camera 2 had a date and time stamp of 02/21/2013 00:42:02.
- At 00:42:05, the Camera times start to diverge in clock speed.
- At 00:42:07 (Camera 1) and 00:42:13 (Camera 2), Mr. Oyamada first comes into view walking west on the south side of 40th Avenue.

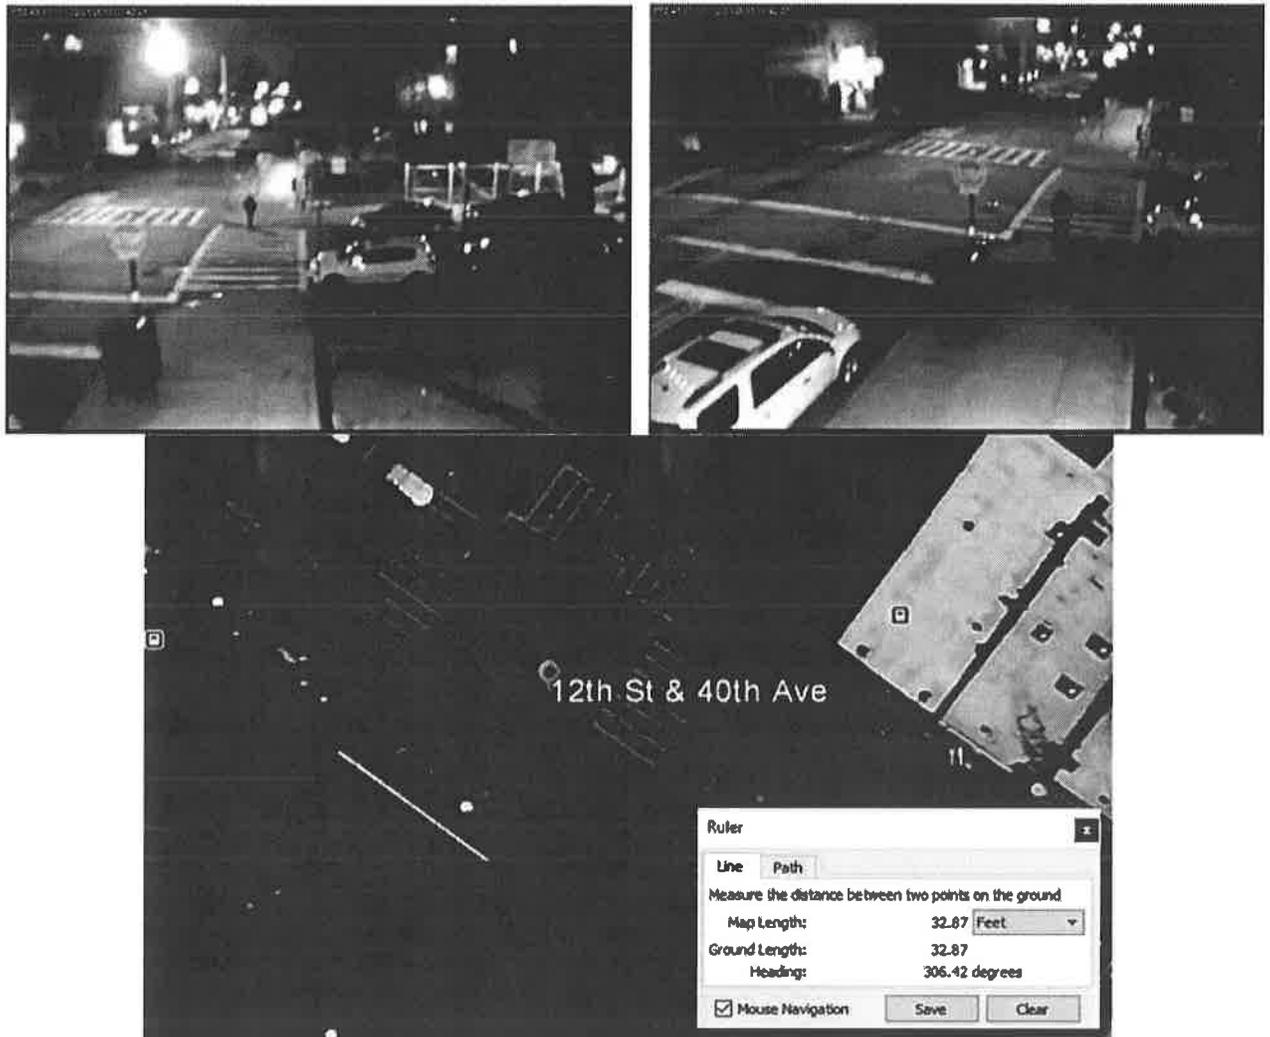
Figure 1: Pedestrian Crossing across 12th Street, South Side

- Mr. Oyamada entered the crosswalk on 12th Street at 00:42:21 and left the crosswalk at 00:42:27 (See Figure 1).

From Satellite analysis of the intersection and video analysis, Mr. Oyamada took approximately 6 seconds to cover 32.9 feet, which would result in a pedestrian walking a speed of 5.5 feet per second.

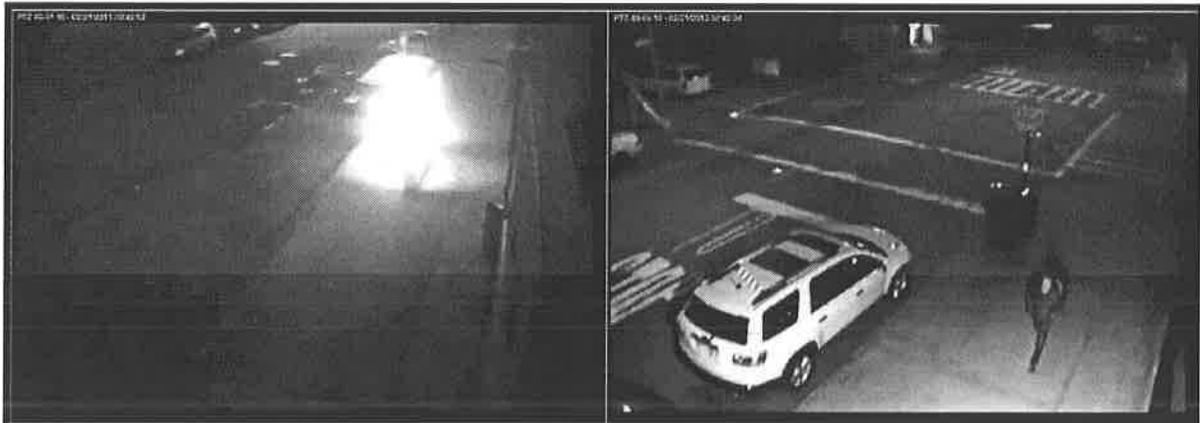
- At 00:42:52 (Camera 1) and 00:42:34 (Camera 2), Mr. Oyamada crossed 12th Street and was walking proximate to the location of Camera 2.

- The entire time Mr. Oyamada appears walking in sight of Camera 2, Mr. Oyamada walks at a steady pace, in a straight path, and in a controlled manner.
- From this point forward, Mr. Oyamada ceases to appear on video.
- At 00:43:40 (Camera 1) and 00:43:17 (Camera 2), the front of the neighborhood store was captured in view as Camera 1 began to swing to look west. There were 3 pedestrians in view, with the right-most pedestrian seen walking to the group on the left.

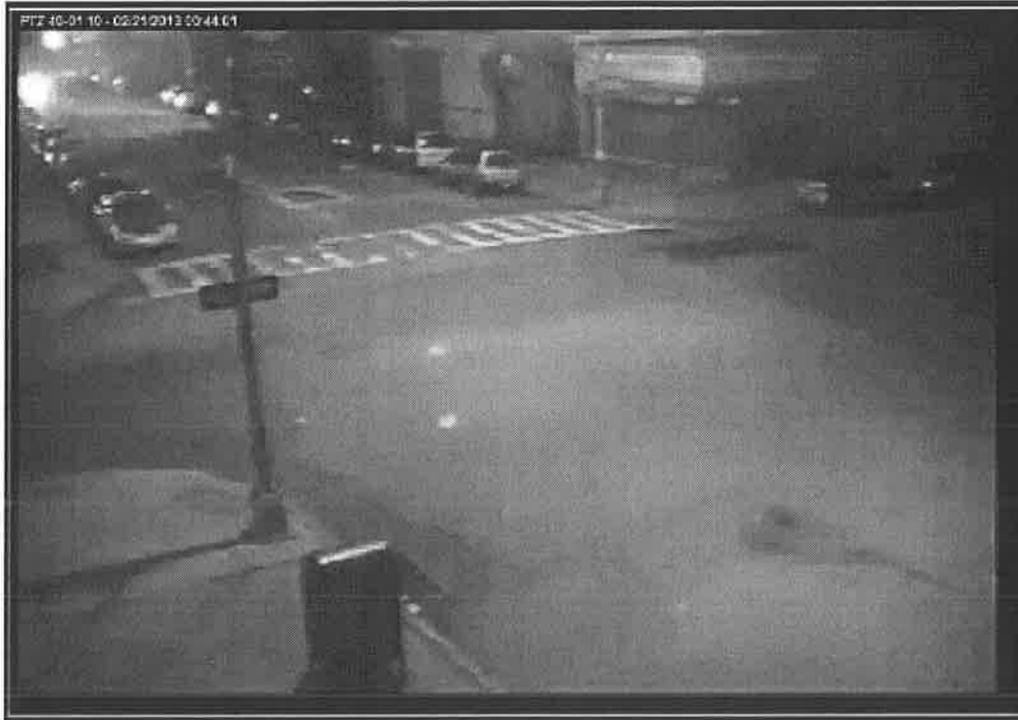
- At 00:44:01 (Camera 2), the Police car headlights appear in view on Camera 1, which is now facing west. The Police car just crossed the pedestrian crosswalk located at the intersection of Vernon Blvd and 40th Avenue. The Vernon Blvd and 40th Avenue intersection was a light controlled intersection.

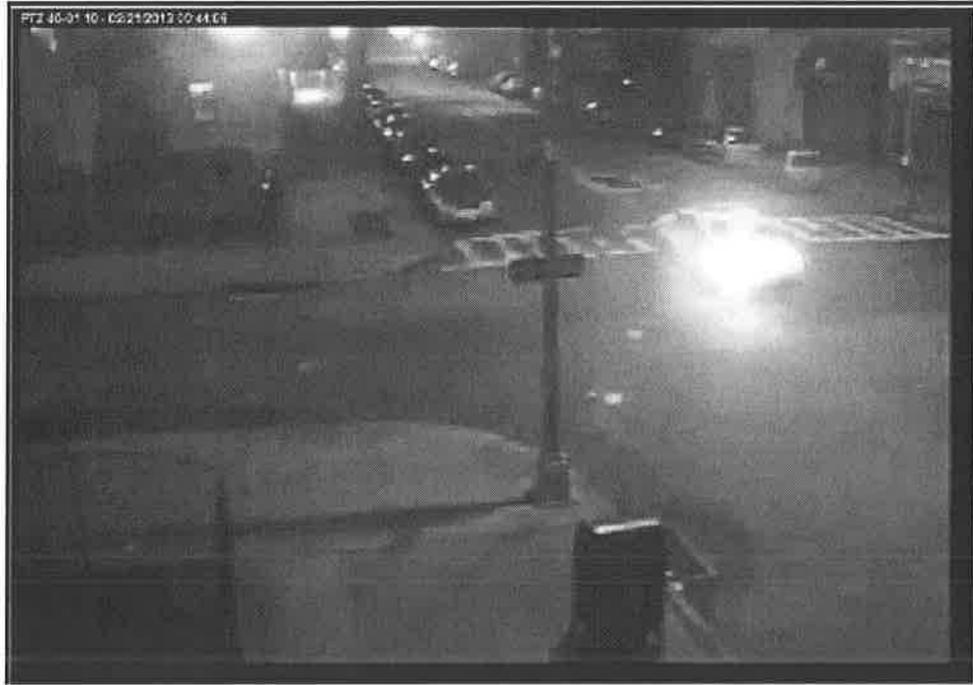
Figure 2: Car Entering Intersection

- At 00:44:06 (Camera 1), the Police car crossed the crosswalk across 40th Avenue located on the west side of the intersection of 10th Street and 40th Avenue (See Figure 3). Brake lights are seen just after the car crossed the crosswalk.

Therefore, from 64.6 to 0 mph at the max deceleration rate, the Police car would have required 3.4 seconds and 162.6 feet to stop. This was entirely consistent with the video showing brake light activation (amber) as the police car crossed over the pedestrian crosswalk at 10th Street and crossing the intersection (See Figures 2, 3, and 10).

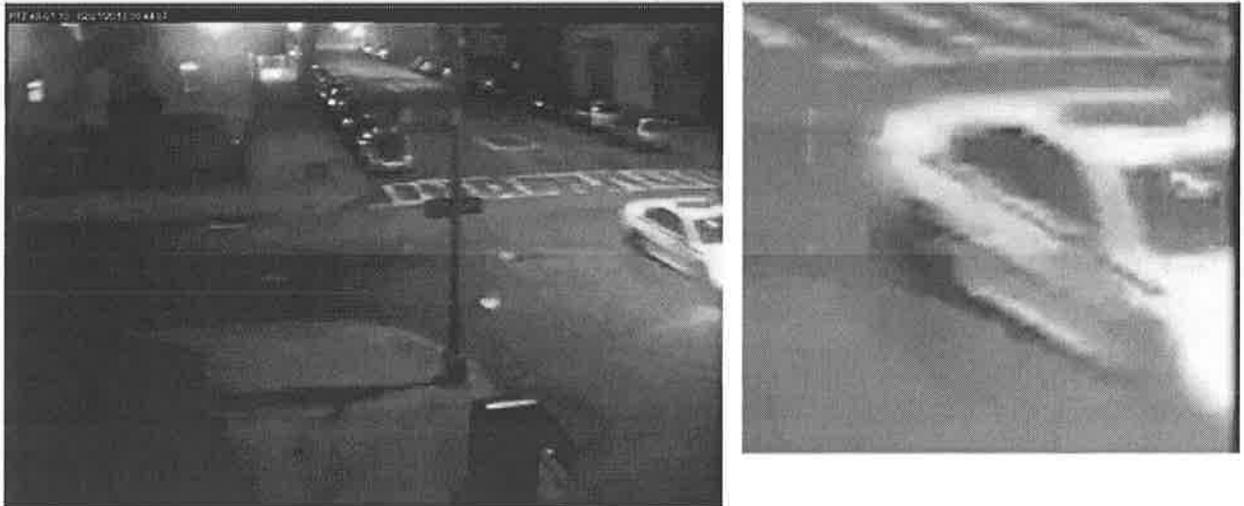
Figure 3: Car Exiting View

- At 00:44:07 (Camera 1), the Police car begins to leave the camera's field of view (See Figure 3).

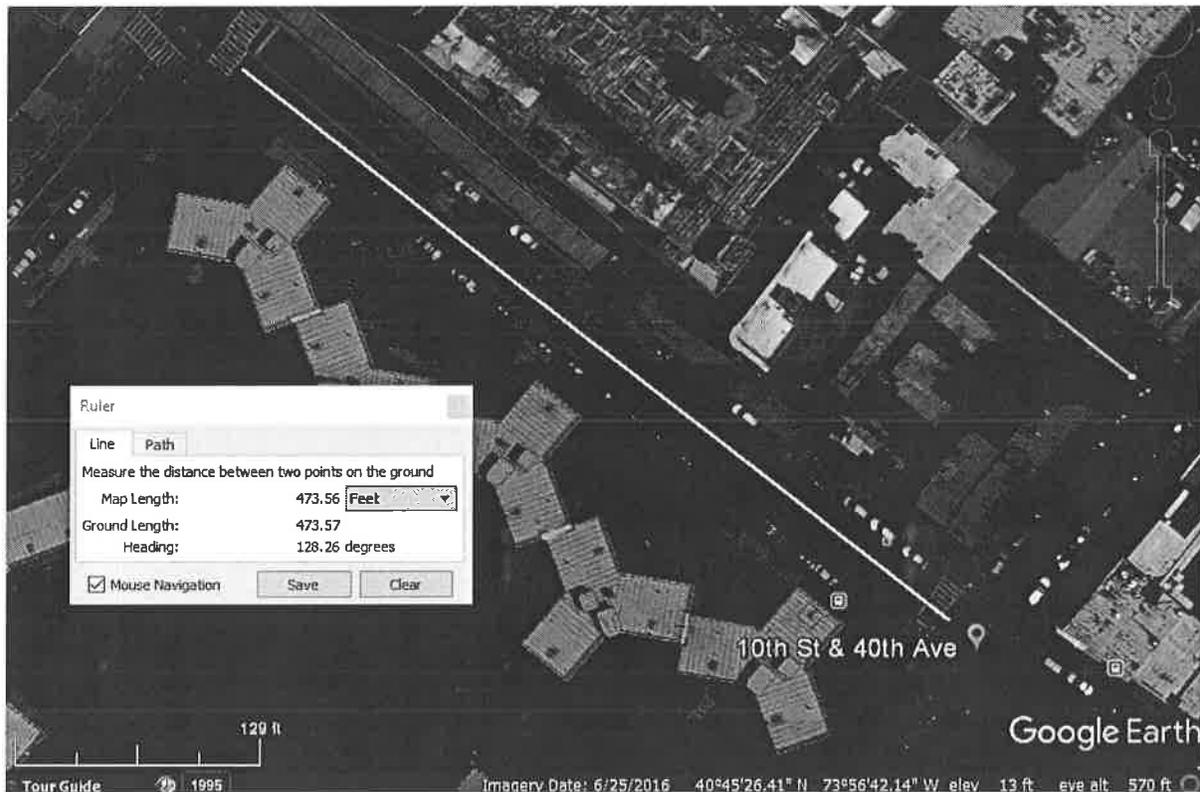
Figure 4: Distance of Travel of Police car in Video

- There was no evidence in the video that the Police car had any emergency lights or signals on. Furthermore, we can see in the video that the Police car was entering the intersection driving in the middle of the road, whereas 40th Avenue was a two lane road that runs eastbound and westbound.
- From Satellite analysis, we find that the distance between entering and crossing the crosswalk at Vernon Blvd and crossing the crosswalk at 10th Street was a distance of 473.6 feet (See Figure 4).

Given the time difference of 5 seconds to travel 473.6 feet, the Police car was traveling at an average of 94.7 feet per second, or 64.6 mph. It is likely that the Police car was going a slower speed at the time of entering 40th Avenue at Vernon Blvd, and therefore was going a higher speed upon entering the intersection of 10th Street and 40th Avenue.

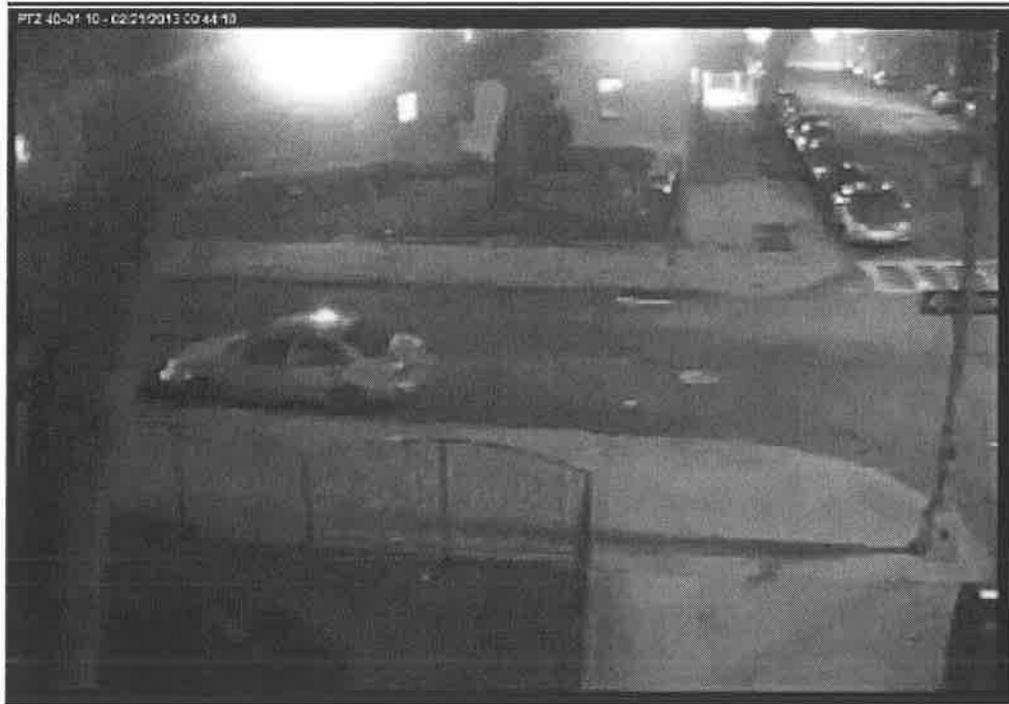
- At 00:44:10 (Camera 1), presumably after the incident, lights from the Police car are now seen flashing in the video, reflecting off of the street pole and signs.

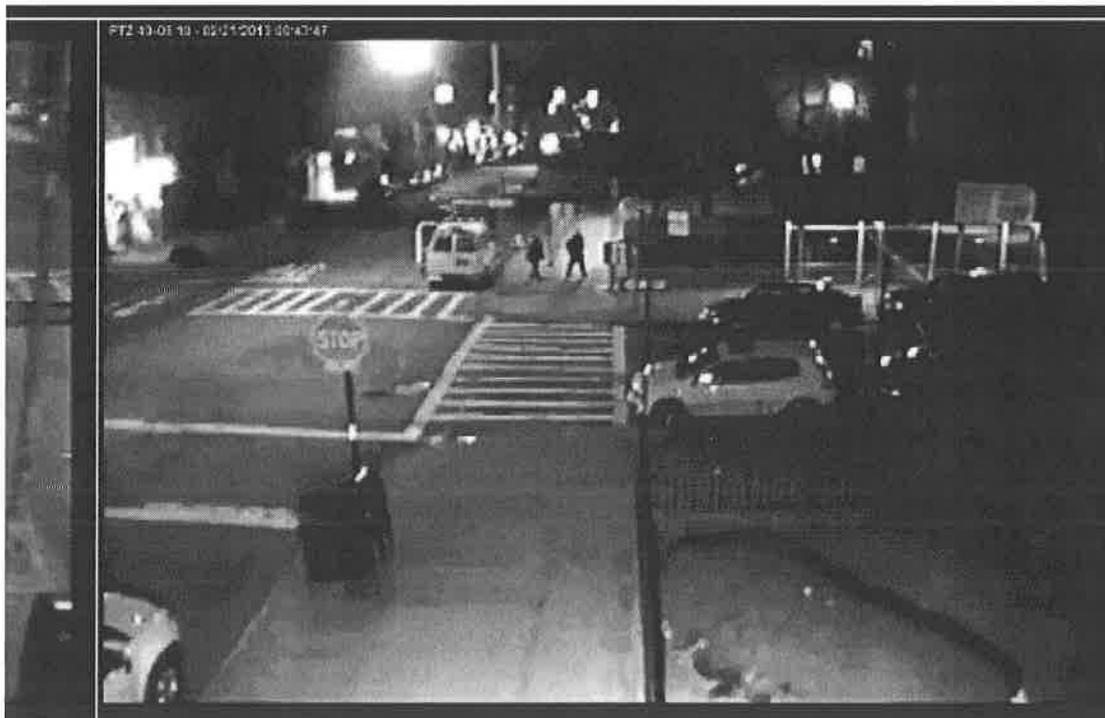
- At the same time 00:43:17 (Camera 2), a Police Van is in view across 12th Street. The police van panned into view on Camera 2 at approximately 00:43:43 (Camera 2) time and 00:44:05 (Camera 1) time, while the Police car was one car length away from the crosswalk at 10th Street.

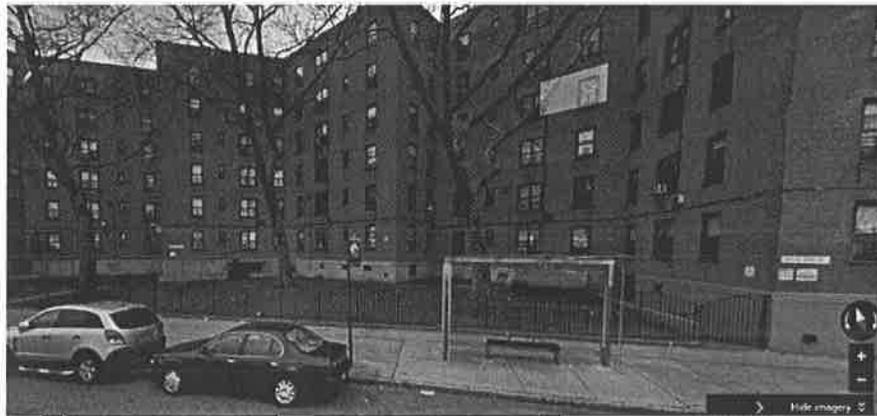
- There was a link from The Gothamist to a bystander video captured on social media. The video was useful in identifying the point of rest of Mr. Oyamada. When comparing to publicly available street view, Mr. Oyamada's point of rest was at or about the center of the road in line with a bus stop sign located on the south side of 40th Avenue (See Figure 5).
- When querying satellite information, the distance from 10th Street to the point of rest was approximately 125.73 feet.

- Point of Rest
- Bus Stop Sign
- Lit Bus Stop

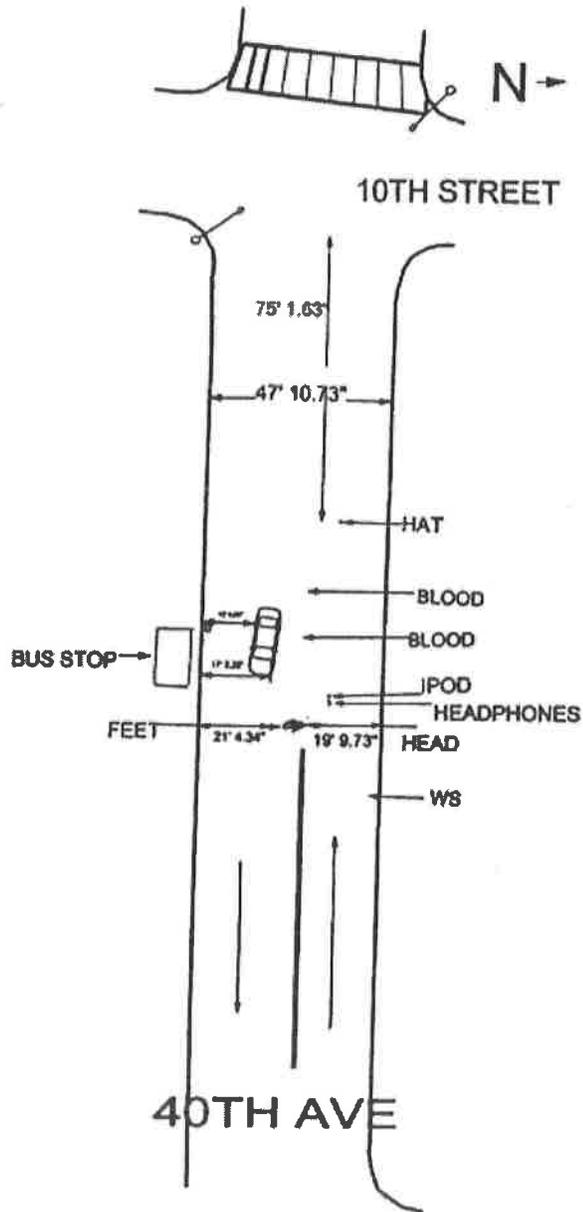
Figure 6: Police Diagram

The police produced a diagram with dimensions of the road and of points of rests of evidence such as a hat, blood, and items deposited as a result of the collision (See Figure 6).

The road was measured to be 47 feet, 10.73 inches. At 5.5 feet per second, Mr. Oyamada would require 8.7 seconds to cross the road in the narrowest dimension. Assuming Mr. Oyamada was crossing from south to north at the time the Police car was essentially two blocks away at Vernon Blvd., Mr. Oyamada would have been somewhere in the eastbound lane when struck.

The spot check of measurements were largely consistent with the police scene diagram (See Figure 6), and satellite queries, and therefore the Accident Reconstruction Analysis and conclusions remain unchanged.

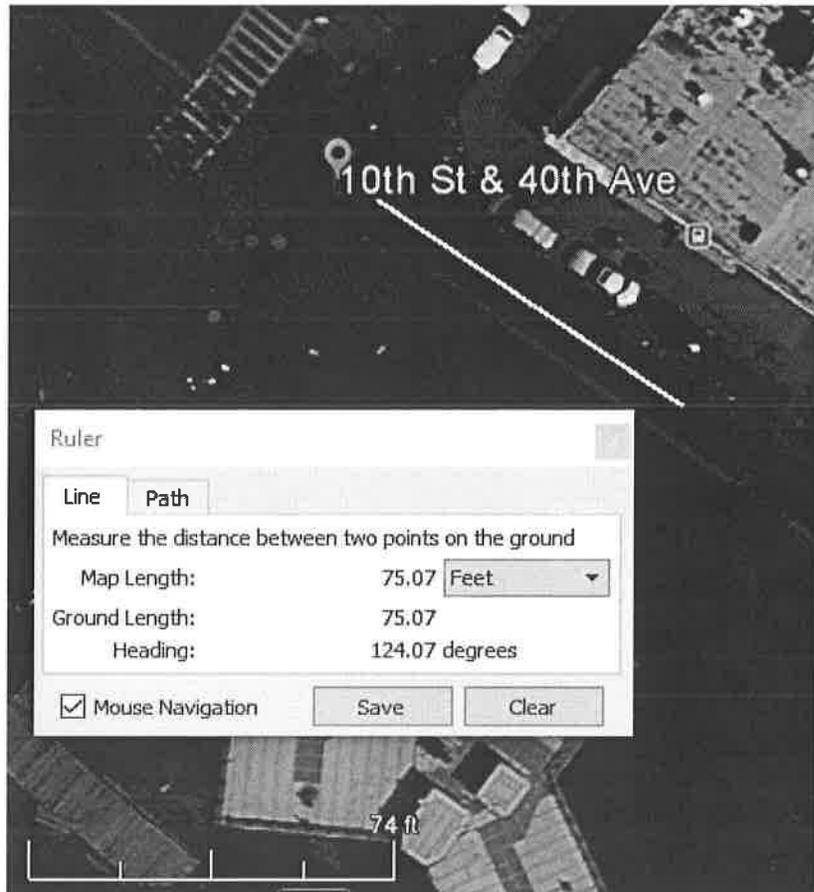
Figure 7: Location of Hat

The police reports indicate that Mr. Oyamada was struck approximately 60 feet east of 10th Street. Based on accident reconstruction methodology taught at SAE, items deposited on the road are a good indicator of points of impact. The hat was located approximately 75 feet from 10th Street, which would be approximately in line with the east end of the market (See Figure 7), and would be consistent with an impact in an area around the door of the store. The hat, iPod, and headphones were located in the westbound lane, indicating that Mr. Oyamada was likely struck in the westbound lane somewhere between the centerline of the road and the northern edge of the road.
REDACTED

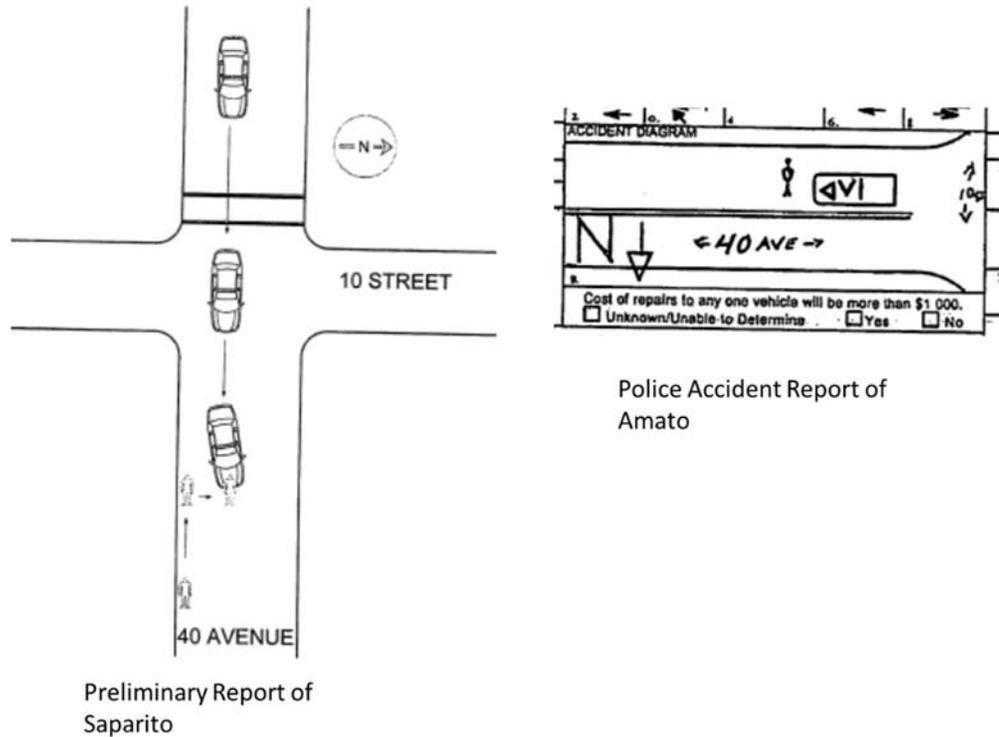
Figure 8: Police Sketches

Oyamada further evidences that Mr. Oyamada was struck in the westbound lane of 40th Avenue and that the Police car actually steered back towards the eastbound lane after the impact. The video, the police diagram in Figure 6, and the police narrative were therefore entirely in conflict with the police sketch in the Preliminary Report and Police Accident Report (See Figure 8).

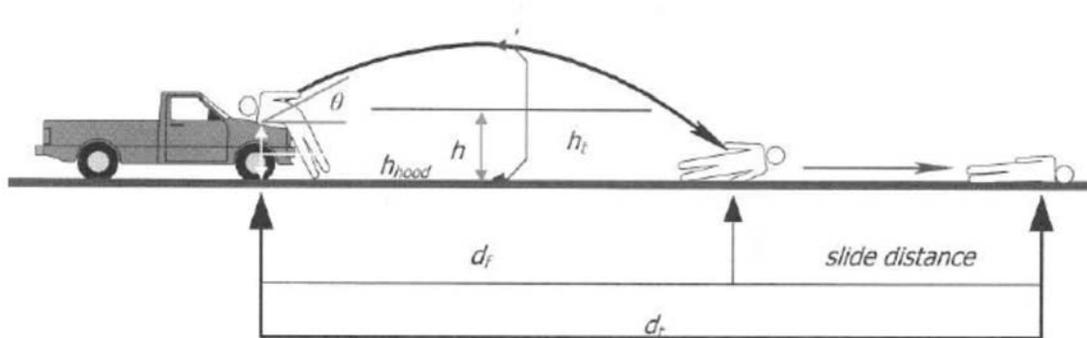
Figure 9: Diagram of Inputs to Pedestrian Throw Equations
(G. Russell, Equations & Formulas for the Traffic Accident Investigator and Reconstructionist)

Given that we know the point of rest of Mr. Oyamada (approximately 125.7 feet from 10th Street) and the estimated point of impact (approximately 60 feet from 10th Street), and we know that Mr. Oyamada was struck and experienced a wrap and throw (from the narrative), then we can determine the collision speed using a variety of pedestrian impact equations (See Figure 9).

Since we do not have all of the variables and information to employ many of the different throw equations, we can use the pedestrian throw equations that employ the total throw distance, which we know to be approximately 50.7 feet. We can further average the results of the different equations to come up with reasonable prediction of collision speed. Summary of different models and equations are now attached as Attachment F. Results of the pedestrian throw analysis are summarized in Table 1.

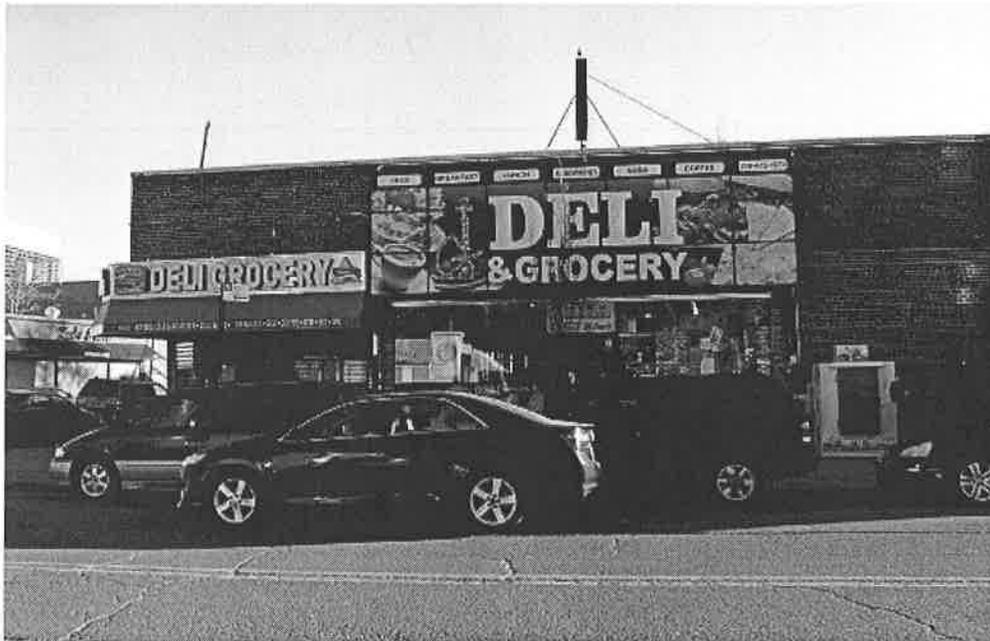
Figure 11: Front of the Store

Some additional information that can be gathered from the site inspection was that the point of impact 60 feet east of 10th Street was somewhere just east of the door and within the profile of the front of the store window and sign (See Figure 11). According to the report of police investigators, video taken at the time of the crash by a camera mounted on the deli was reviewed, but not collected.

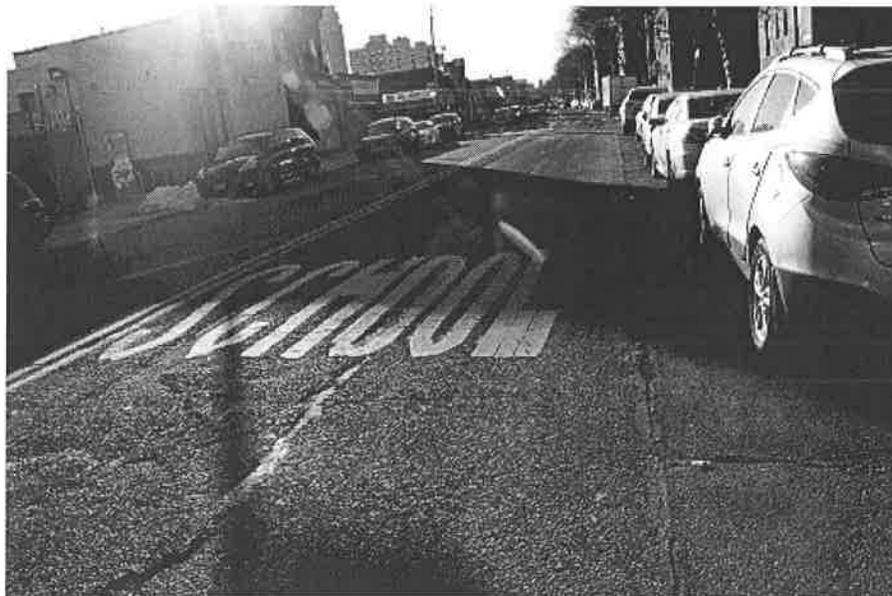
Figure 12: School Roadway Mark

The crosswalk at 10th Street located on the west side of the intersection was actually for a school crossing (See Figure 12). At the time of the inspection, there was a crossing guard.

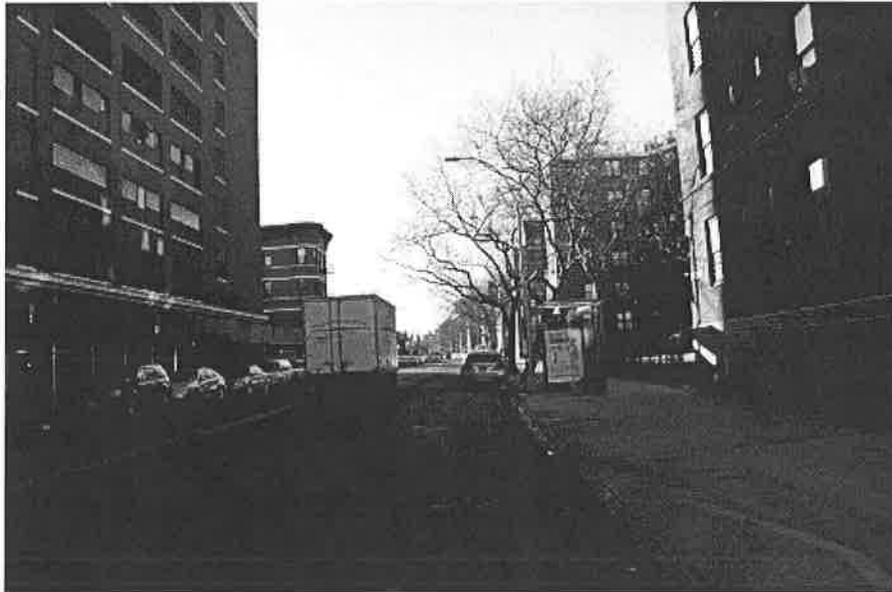
Figure 13: View from Vernon Blvd eastbound down 40th Avenue

There were no posted speed limits from Vernon Blvd to past 10th Street on eastbound 40th Avenue, and the road was essentially flat. Although there was a slight curvature to the road, there was an unobstructed line of sight between Vernon Blvd and 10th Street, although the distance begins to be beyond human sight (See Figure 13).
